AP Inspections, LLC

Summary

Property address: **1234 Sample St.
Pleasant Pl., WA 12345**

Inspection date: **Friday, February 26, 2016**

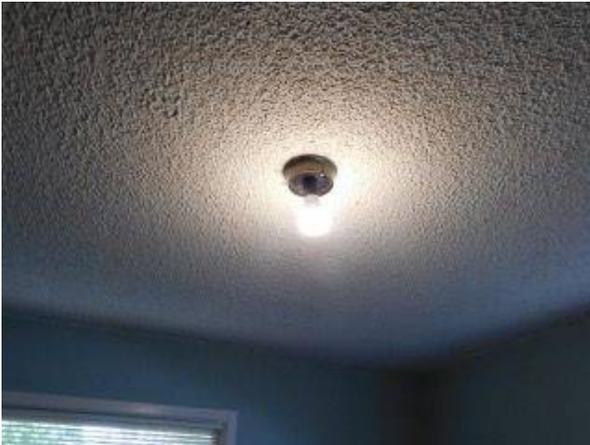
Photo 2-1

Some "cottage cheese" acoustic ceiling finishes and ceiling tiles (photo 2) are known to have asbestos contained in it. Consultation with a specialist, environmental hygienist, is recommended.

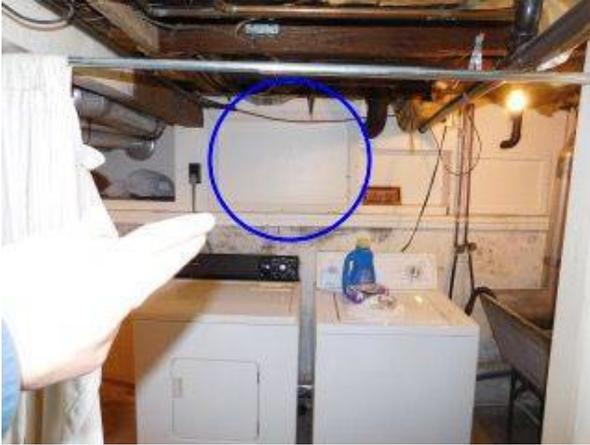
Photo 3-1

Access into the crawlspace obstructed by the washer and dryer limiting the inspection of the crawlspace using a camera from the access portal. The inspector was unable to traverse the crawlspace due to access restrictions.

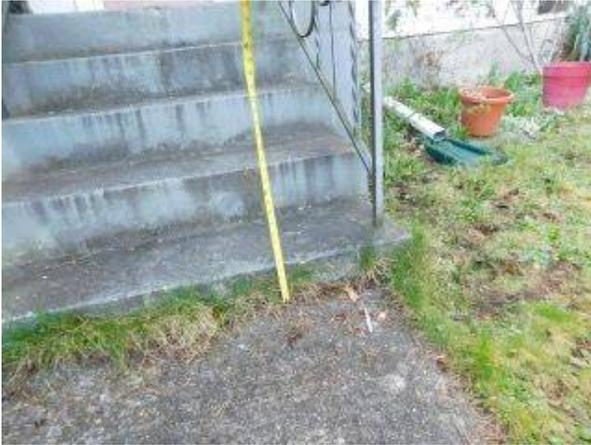
Photo 5-1

The risers for stairs at the front entrance varied in height and pose a fall or trip hazard. Risers within the same flight of stairs should vary by no more than 3/8 inch. At a minimum, be aware of this hazard, especially when guests who are not familiar with the stairs are present. Recommend that a qualified contractor repair per standard building practices.

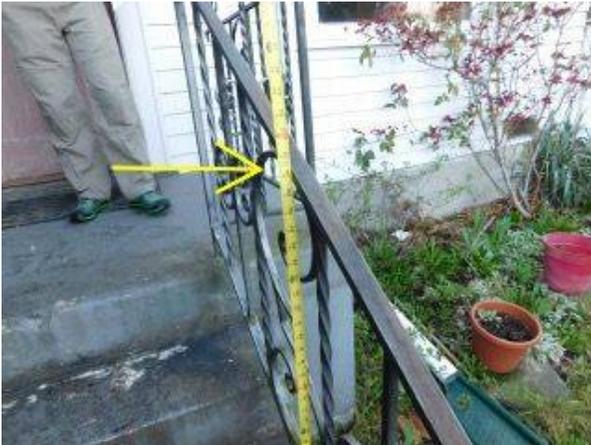
Photo 6-1

Handrails at the front entrance flight of stairs were missing. This is a potential fall hazard. Handrails should be installed at stairs with four or more risers or where stairs are greater than 30 inches high. Recommend that a qualified contractor install handrails where missing and per standard building practices.

Image showing missing handrail. Arrow noting where the handrail should be.

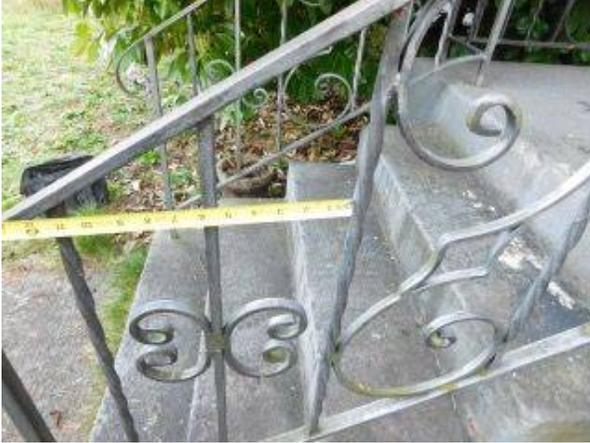
Photo 7-1

Guardrails at the front entrance has a drop-off higher than 30 inches and gaps that are too large. This poses a safety hazard for children (e.g. falling, getting stuck in railing). Guardrails should not have gaps or voids that allow passage of a sphere equal to or greater than 4 inches in diameter, or 6 inches in diameter at triangular spaces between stair edges and guardrails. At a minimum, the client should be aware of this hazard. Recommend that a qualified contractor repair or replace guardrails per standard building practices.

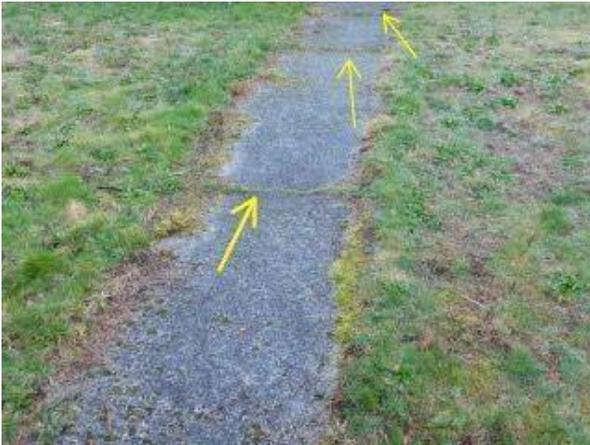
Photo 8-1

Cracks and settlement were found in the sidewalk leading to the front door posing a tripping hazard. Recommend that qualified contractor repair as necessary.

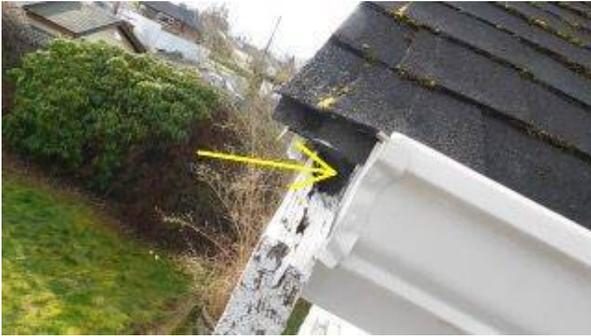
Photo 9-1
Wood trim at the roof line at the front of the house is rotted. Consult with a licensed building contractor to replace and install flashing as per building code.

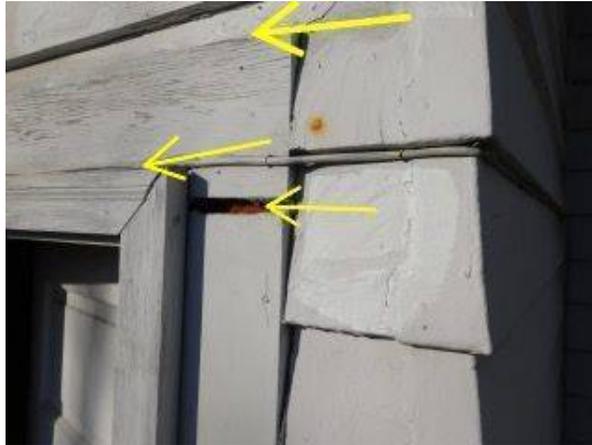
Photo 9-2
Image showing exposed gaps in wood trim and no drip edge flashing over doorway at rear of house.

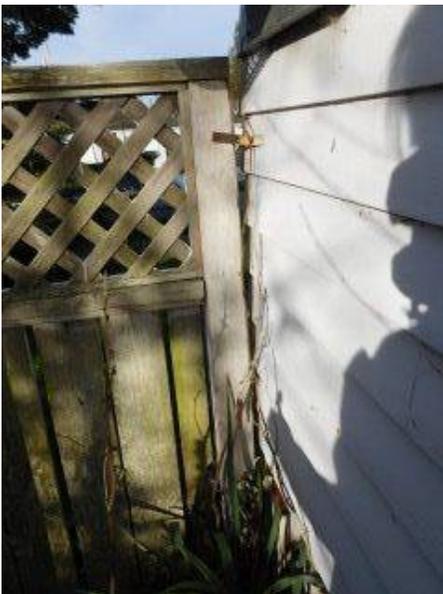
Fences were attached to or in contact with the building exterior at the southwest and the northeast corners of the structure. Such attachments can serve as a pathway for wood-destroying insects and can retain moisture against the exterior after it rains. This is a conducive condition for wood-destroying organisms. Recommend that a qualified person repair as necessary so there is at least a 2-inch gap between fences and building exteriors.

Photo 11-1
Fence at northeast corner of the building.

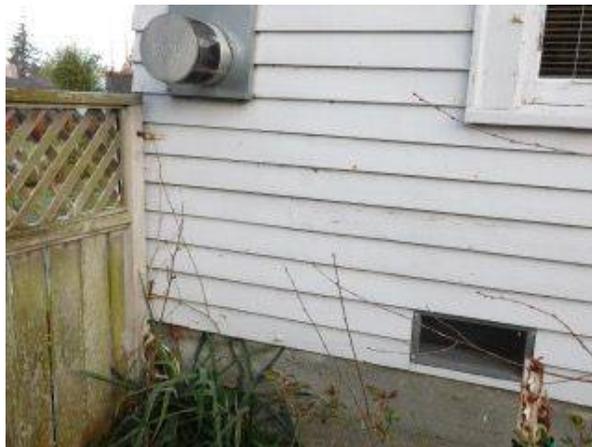
Photo 11-2
Fence at the southwest corner of the building.

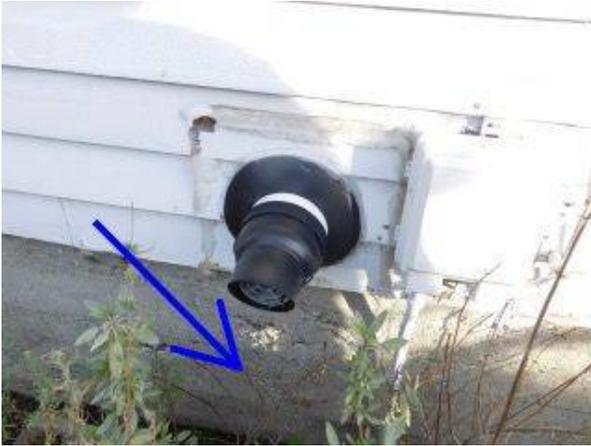
Photo 12-1

"Honeycombing" was found on the south section of the concrete foundation. This occurs when aggregate and sand in the concrete mixture bunches into clusters and fails to mix with the cement paste. This can be caused because the concrete mix was too stiff, by inadequate consolidation (insufficient use of a mechanical concrete vibrator) and pouring the concrete from too high of an elevation. In many cases honeycombing is only a cosmetic issue, but it does make concrete susceptible to water infiltration. Where honeycombing is accessible, recommend that a qualified person fill voids with an approved material such as hydraulic cement or non-shrinking grout.

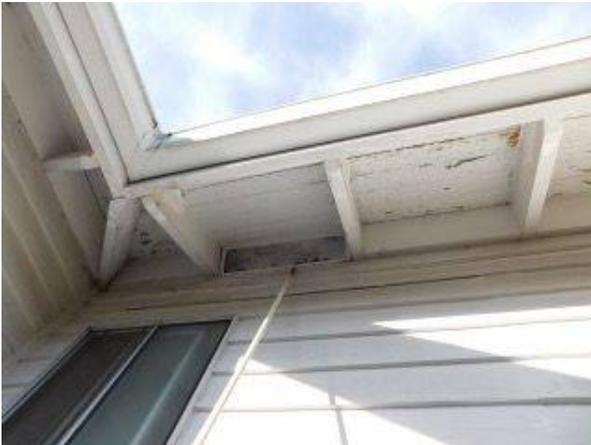
The paint or stain finish over much of the entire structure was failing (e.g. peeling, faded, worn, thinning). Siding and trim with a failing finish can be damaged by moisture. Recommend that a qualified contractor prep (e.g. clean, scrape, sand, prime, caulk) and repaint or restain the entire building exterior per standard building practices. Any repairs needed to the siding or trim should be made prior to this.

Photo 13-1
Image showing peeling paint in the soffit.

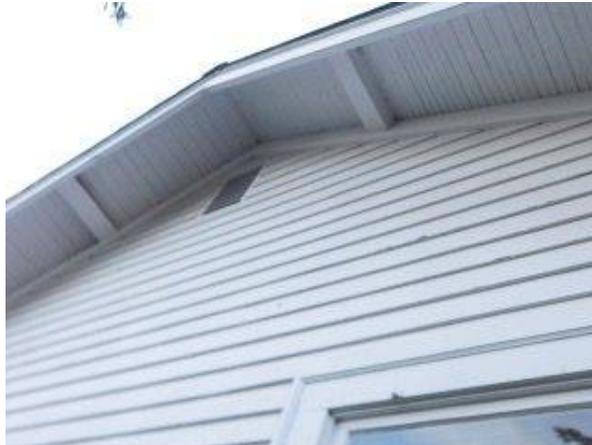
Photo 13-2
Image showing thinning and peeling paint on the siding and soffits.

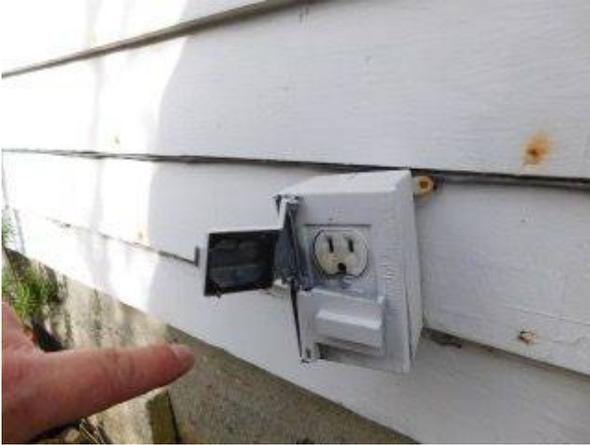
Photo 14-1

Image showing a loose electrical outlet box exposing the substructure to moisture penetration and creating a conducive condition for wood destroying organisms. There is also a safety issue present with this electrical outlet that is described under the "Electrical" category.

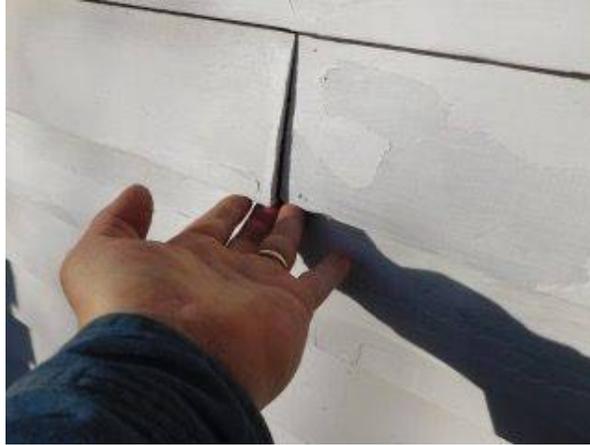
Photo 14-2

Image showing butt joint separated, exposing substructure to moisture. A condition conducive to wood destroying organisms.

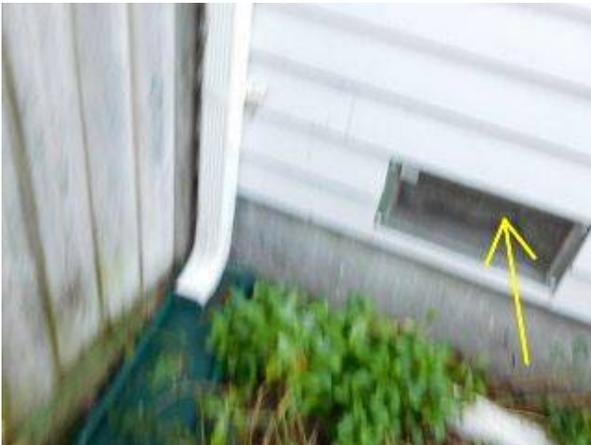
Photo 15-1

Some crawl space vents located along the north and east sides of the structure were intentionally blocked (e.g. removable panels, rigid foam). This restricts ventilation in the crawl space and can result in increased levels of moisture inside. This is a conducive condition for wood-destroying organisms. Such vents should be left open at all times except during severe freezing weather. Recommend removing materials or items blocking vents as necessary.

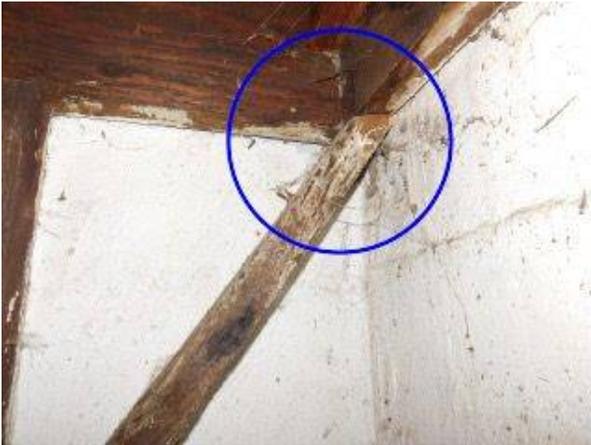
Photo 16-1

The basement exterior entry door appears to be leaking, is damaged and deteriorated. Moisture has penetrated to the substructure of the basement stairs causing rot and presence of wood destroying organisms. Recommend contacting a qualified building contractor to repair door and stair substructure, as necessary, to prevent water from infiltrating the basement. Note that water intrusion creates a conducive condition for wood-destroying organisms.

Presence of wood rot and wood destroying insect activity in the supporting members of the stairway leading down into the basement.

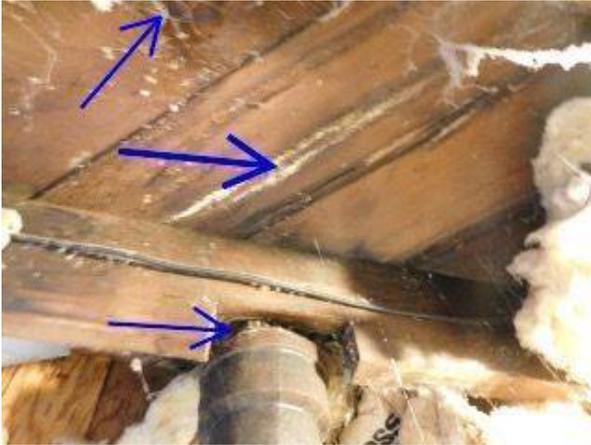
Photo 17-1

Fungal rot was found in multiple sections of the floor sheathing. This condition presents weakening of the structural integrity of the floor causing possible collapse of the floor. Recommend consulting a qualified building contractor to evaluate and repair as necessary.

Image showing fungal rot in the floor sheathing and improper notching of a floor joist. Recommend consulting a qualified building contractor to repair as per building standards.

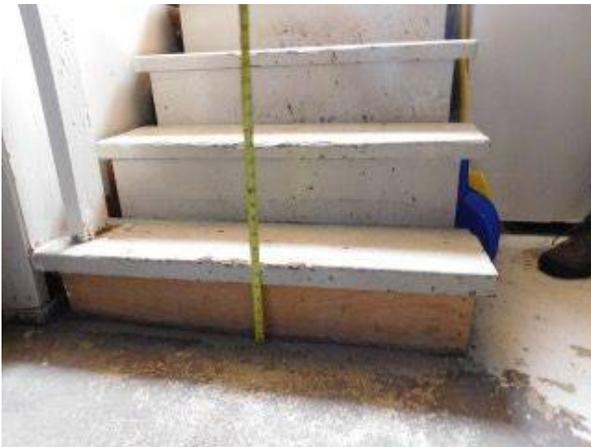
Photo 18-1

The risers for stairs serving the basement varied in height and poses a fall or trip hazard. Risers within the same flight of stairs should vary by no more than 3/8 inch. At a minimum, be aware of this hazard, especially when guests who are not familiar with the stairs are present. Recommend that a qualified contractor repair per standard building practices.

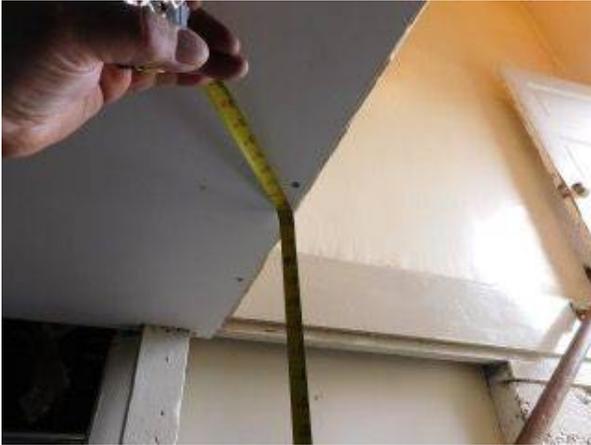
Photo 19-1

The ceiling height over stairs serving the basement was too low and poses a safety hazard, especially for tall people. Ceilings over stairs should be at least 6 feet 8 inches high. At a minimum, be aware of this hazard, especially when guests who are not familiar with the stairs are present. Recommend that a qualified contractor repair per standard building practices.

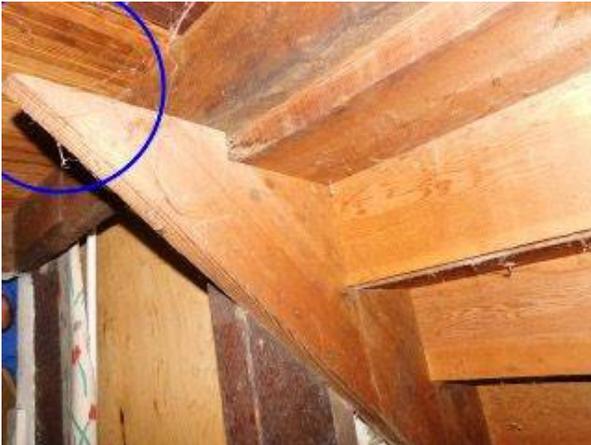
Photo 20-1

The stringers for the stairway serving the basement are substandard construction. Missing bracing and substandard attachment to the structure creates a safety hazard due to potential collapse. Recommend contacting a qualified building contractor to repair as per standard building practices.

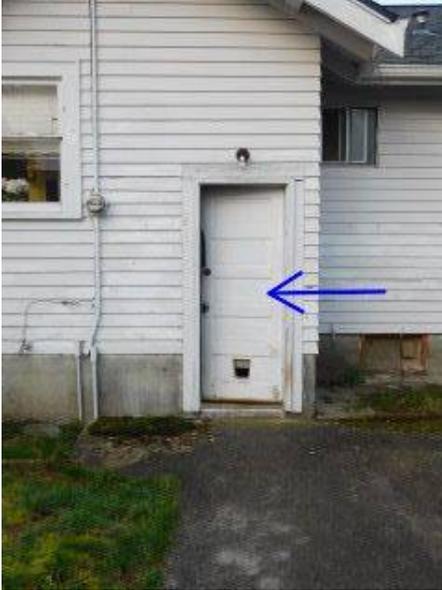
Photo 22-1

The only entrance/exit to the basement was the basement stairs. While this is common in older homes, modern standards require a secondary escape for use in the event of fire or an emergency. Such entrances/exits should allow entry by emergency personnel and their equipment. It is beyond the scope of this inspection to verify compliance with the current codes, and codes are generally not retroactive. Recommend consulting with a qualified building contractor and/or the local municipal building officials regarding egress guidelines.

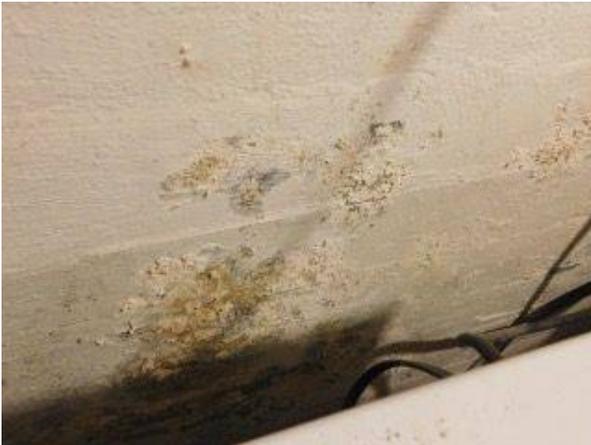
Photo 23-1

Ideally, water should not enter basements, but if water must be controlled after it enters the basement, then typical repairs include installing a sump pump.

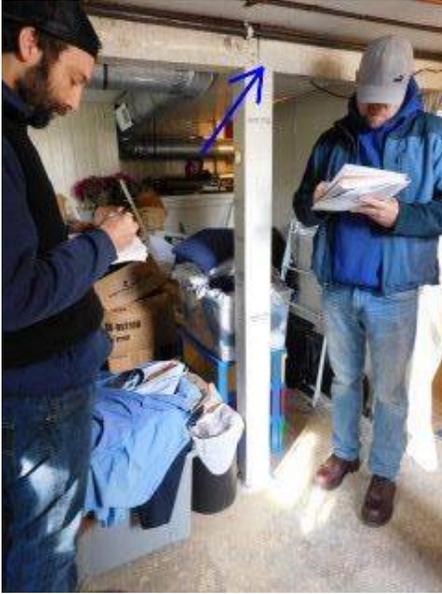
Photo 24-1

Support posts in the basement were not positively secured to the beam above. While this is common in older homes, current standards require positive connections between support posts and beams above for earthquake reinforcement. Recommend that a qualified contractor repair per standard building practices. For example, by installing metal plates, plywood gussets or dimensional lumber connecting posts and beams.

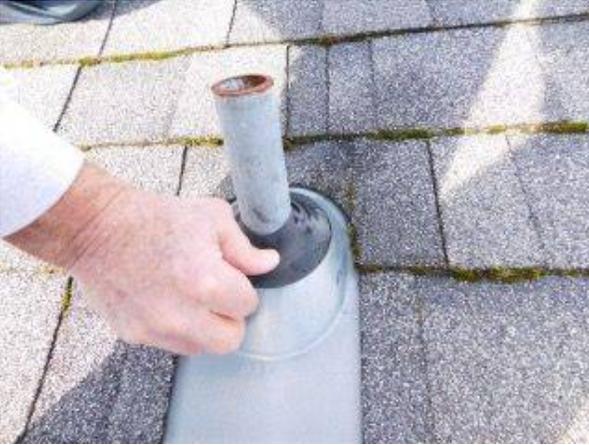
Photo 26-1

Rubber or neoprene pipe flashings were split and cracked at the north drain vent. Leaks can occur as a result. This is a conducive condition for wood-destroying organisms. Recommend that a qualified contractor replace flashings where necessary.

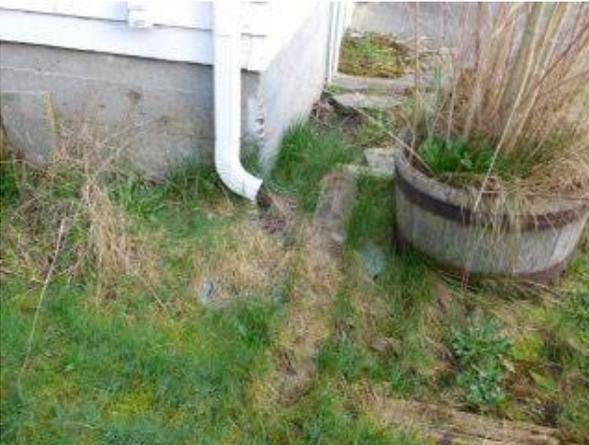
Photo 27-1

Extensions such as splash blocks or drain pipes for downspouts at the southeast corner of the structure, were missing and/or substandard. Water can accumulate around the building foundation or inside crawl spaces or basements as a result. Recommend that a qualified person install, replace or repair extensions as necessary so rainwater drains away from the structure.

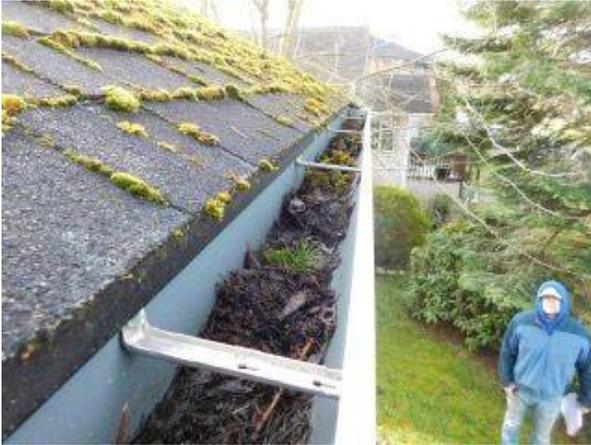
Photo 28-1

Significant amounts of debris have accumulated in gutters located on the west and east sides of the structure. Gutters can overflow and cause water to come in contact with the building exterior, or water can accumulate around the foundation. This is a conducive condition for wood-destroying organisms. Recommend cleaning gutters and downspouts now and as necessary in the future.

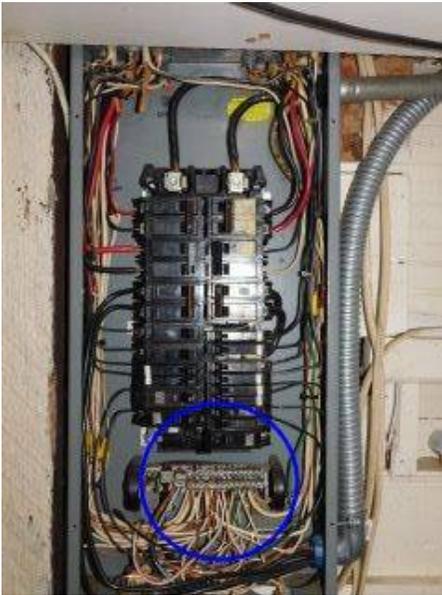
Photo 33-1

Neutral wires were doubled or bundled together under the same lug on the neutral bus bar in the main panel. This is a potential safety hazard in the event that one of the circuits needs to be isolated during servicing. For one neutral to be disconnected, other neutrals from energized circuits sharing the same lug will be loosened. Power surges may result on the energized circuits and result in damage or fire. Also, multiple wires under the same lug may not be secure, resulting in loose wires, arcing, sparks and fire. Recommend that a qualified electrician repair per standard building practices. For more information, visit: <http://www.reporthost.com/?DTNB>

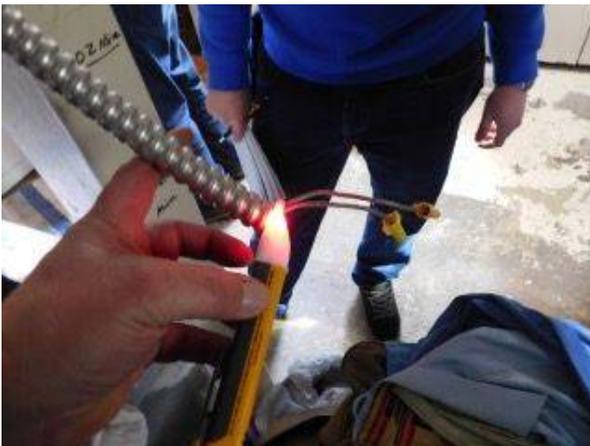
Photo 34-1

Bare wire ends, or wires with a substandard termination, were found in the basement. This is a potential shock hazard. Recommend that a qualified electrician repair as necessary. For example, by cutting wires to length and terminating with wire nuts in a permanently mounted, covered junction box.

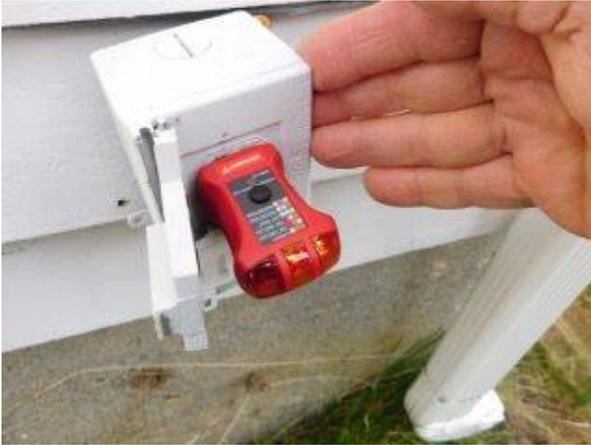
Photo 35-1

Electric receptacle/box located on the south exterior wall was loose and not securely anchored. Wire conductors can be damaged due to repeated movement and/or tension on wires and insulation can be damaged. This is a shock and fire hazard. Recommend that a qualified electrician repair as necessary.

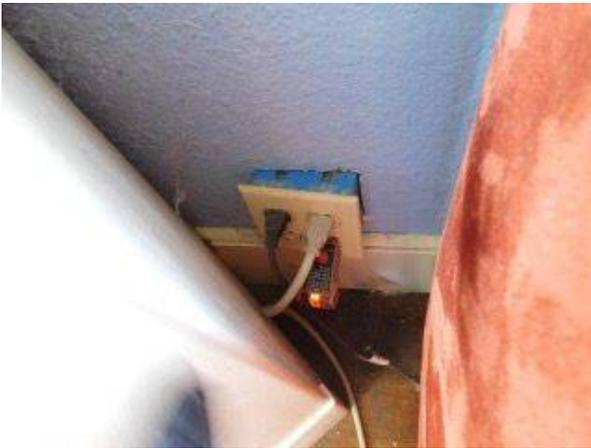
Photo 36-1

A 3-slot electric receptacle located in the living room, was found with an open ground. This is a shock hazard when appliances that require a ground are used with these receptacles. Examples of such appliances include computers and related hardware, refrigerators, freezers, portable air conditioners, clothes washers, aquarium pumps, and electrically operated gardening tools. Recommend that a qualified electrician repair as necessary so all receptacles are grounded per standard building practices.

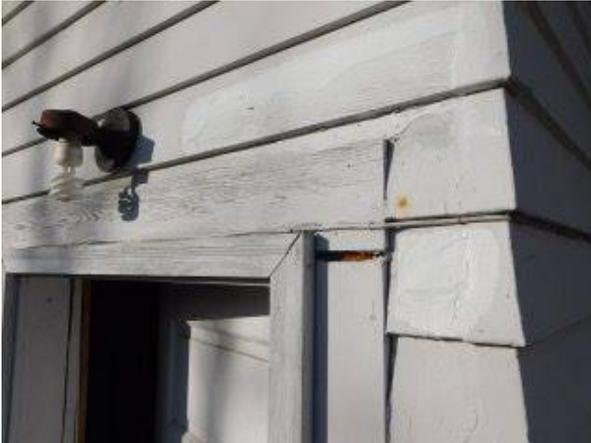
Photo 37-1

Light fixtures located at the rear entrance door to the house and the front door are past their intended service life. Such old components may pose a fire or shock hazard. Recommend consulting with a qualified electrician to determine which components should be replaced with newer, modern components.

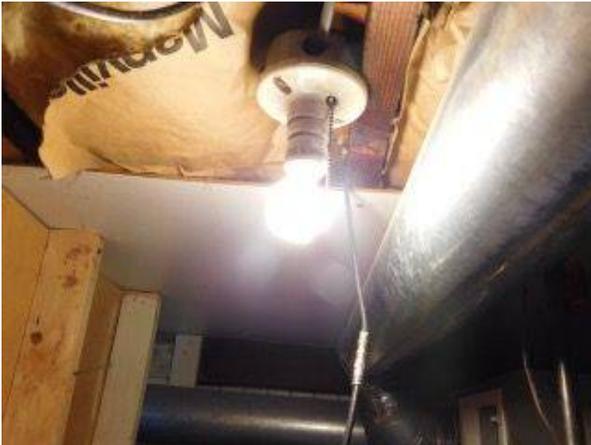
Photo 38-1

Globes or covers for light fixtures were missing at rear door entrance to the structure and, overhead lights in the basement and the office indoors. Recommend replacing as necessary to avoid exposed bulbs.

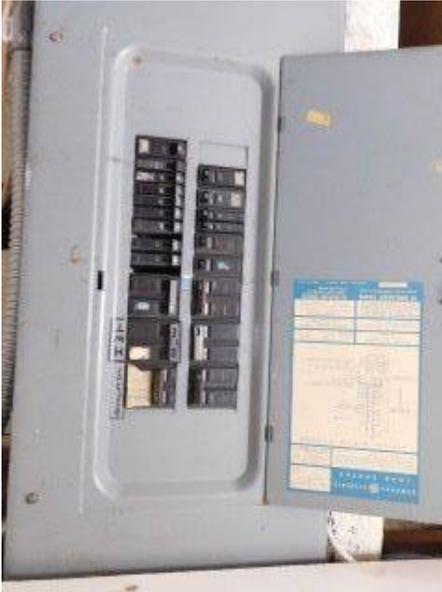
Photo 39-1

The legend for circuit breakers in the main panel was missing. This is a potential shock or fire hazard in the event of an emergency when power needs to be turned off. Recommend correcting the legend so it's accurate, complete and legible. Evaluation by a qualified electrician may be necessary.

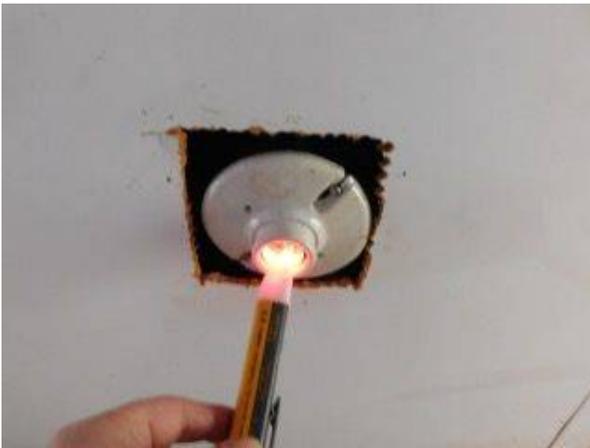
Photo 40-1

Bulb in light fixture located in the basement was missing. This light fixture couldn't be fully evaluated. Recommend installing a light bulb and lens. If the fixture is inoperable after installing light bulb, recommend contacting a qualified electrician to repair or replace as necessary.

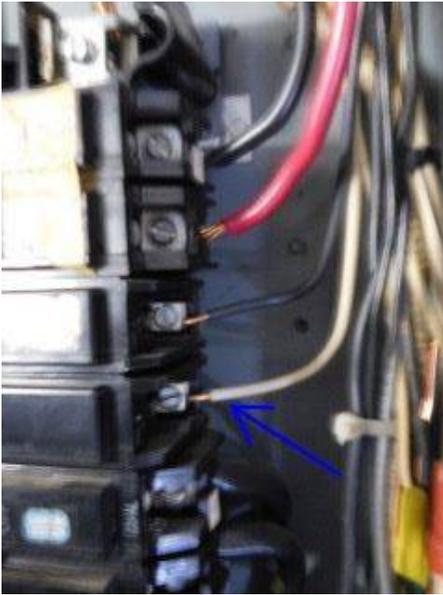
Photo 41-1

41) There is unmarked/identified white wire attached to the power bus bar. This poses a shock hazard for electricians doing repairs on the electrical system. Recommend contacting a qualified electrical contractor for repairs per standard building practices.

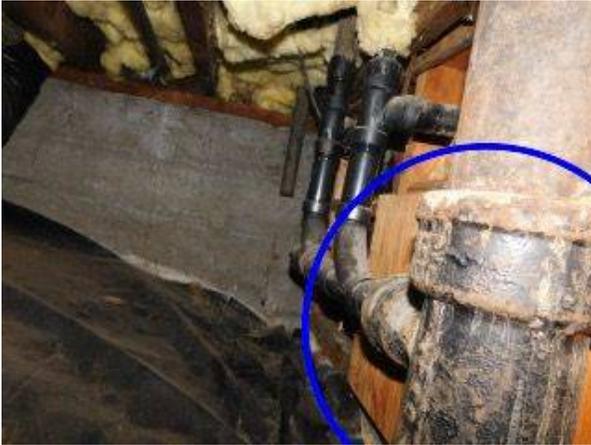
Photo 42-1

Stains were found in waste lines located in the crawl space, but no active leaks were found near the stains. This may indicate that past leaks have occurred. Monitor these areas in the future for leaks or have a qualified plumber evaluate and repair as necessary.

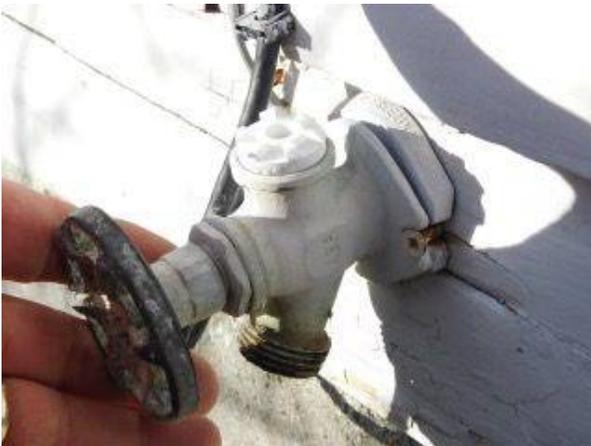
Photo 43-1

Hose bib located at the southeast corner of structure appeared to be inoperable. No water flowed from the bib because the valve was frozen shut. Recommend contacting a qualified person to replace.

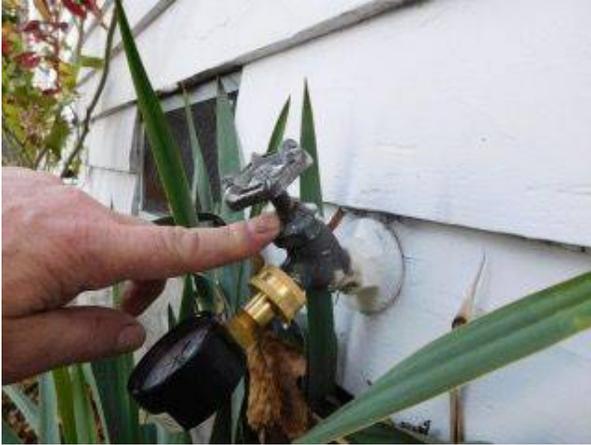
Photo 44-1

This bib should be replaced with a frost free bib. Recommend contacting a qualified plumber to replace.

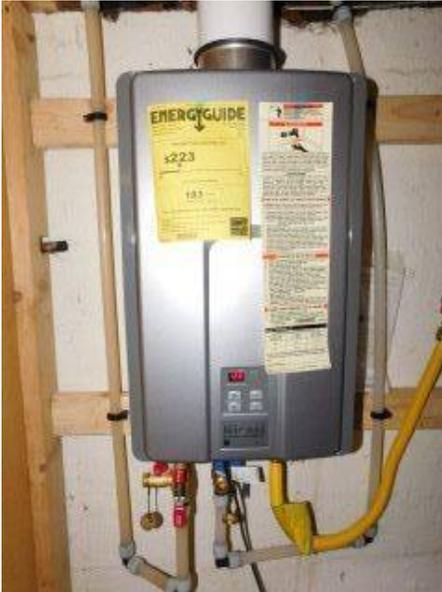
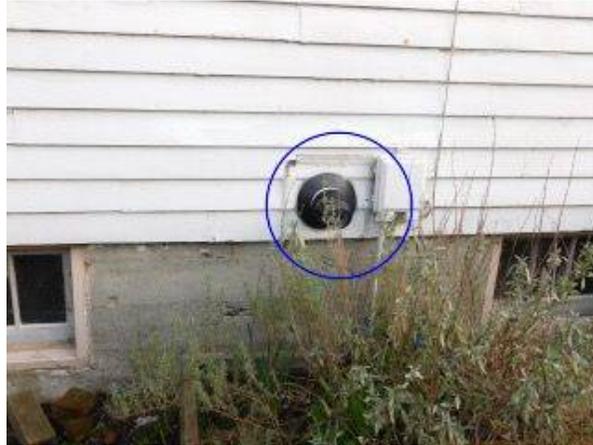
Photo 45-1

45) This system was installed five years ago and is functioning well. The vent pipe penetrating the exterior wall has open gaps around the pipe. This condition exposes the substructure to moisture intrusion which creates an environment conducive to wood destroying organisms. Recommend sealing with an appropriate caulking material as soon as possible..

Image showing the tankless water heater.

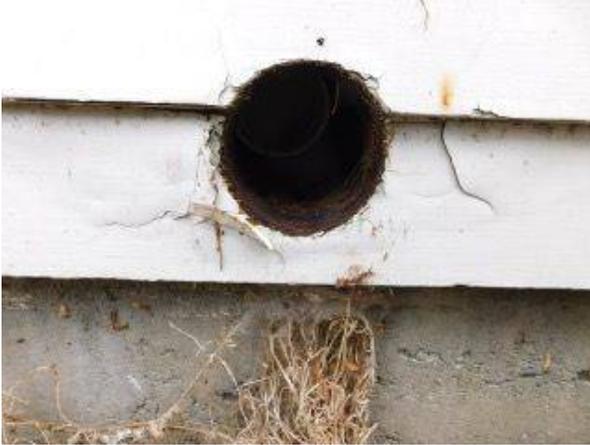
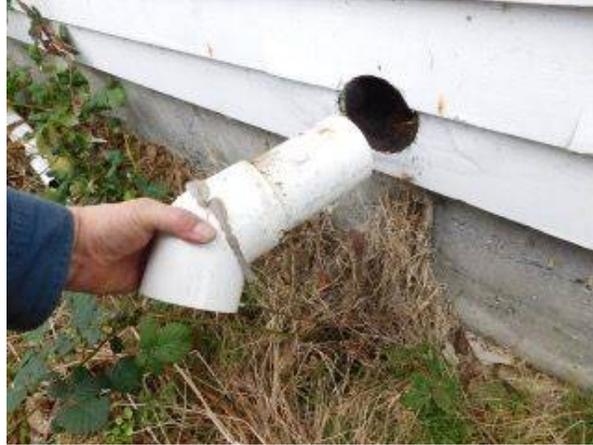
Photo 46-1

The furnace exhaust pipe is disconnected from the end cap at the north side of the crawl space. This condition creates a potential health/safety issue since products of combustion are being discharged into the crawl space and then potentially into living spaces through vertical structural passages, alleys or other openings where systems or equipment penetrate into the living space. Recommend contacting a qualified HVAC contractor to repair as per standard building practices.

Image showing the furnace exhaust pipe portal through the siding.

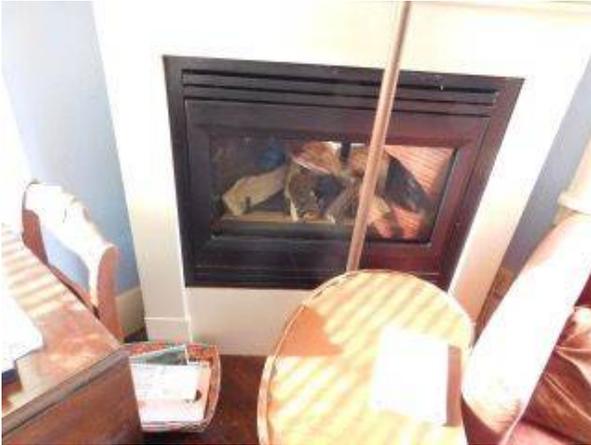
Photo 49-1

49) Inspector unable to inspect the fireplace due to furniture stored in the living room.

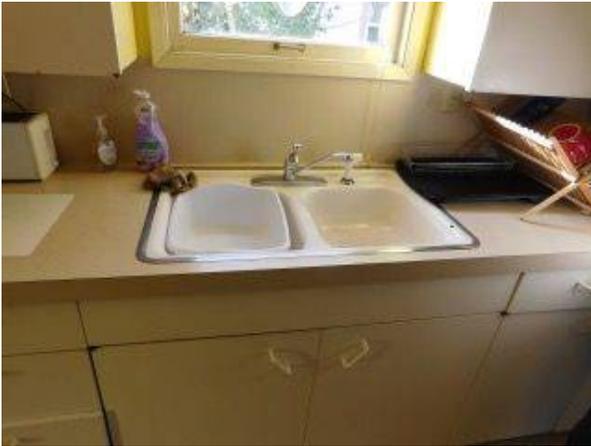
Photo 51-1

Countertops and backsplashes made of formica were aged and deteriorated. Recommend replacing as necessary.

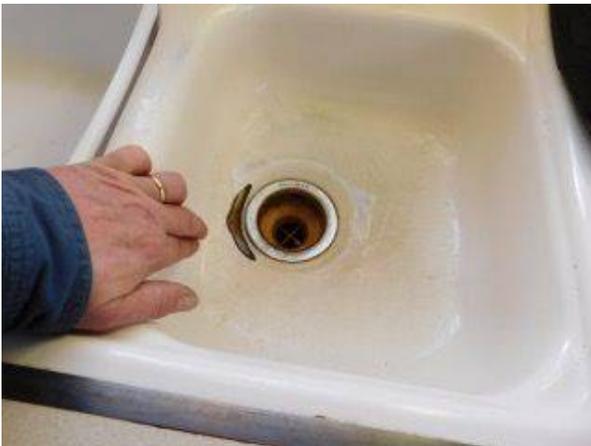
Photo 52-1

The sink was damaged or significantly deteriorated. Recommend that a qualified contractor replace the sink.

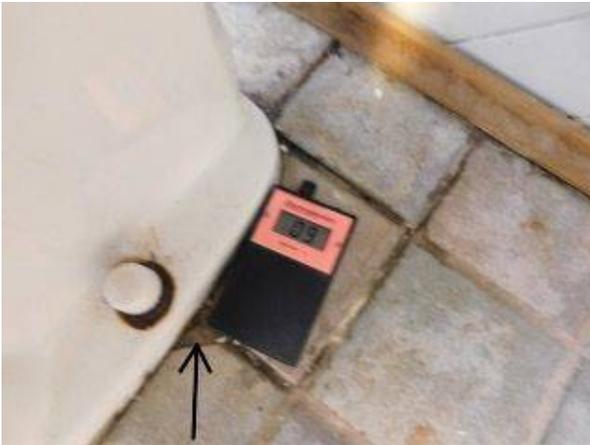
Photo 55-1

Tile and grout flooring in the bathroom was deteriorated (e.g. loose or cracked tiles, missing grout) or substandard. Water can damage the sub-floor as a result. This condition creates an environment conducive to wood destroying organisms and should be repaired as soon as possible. Recommend that a qualified contractor repair or replace as necessary.

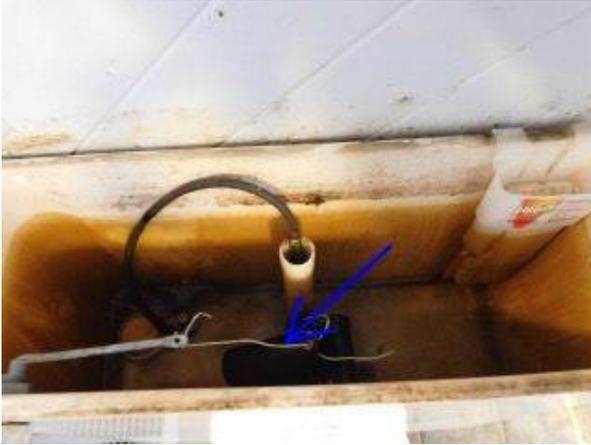
Photo 56-1

Fill valve/float mechanism is functioning however it is constructed with a sub- standard mechanism. Mounting bolts are rusted and need to be replaced. Recommend a qualified person repair as necessary.

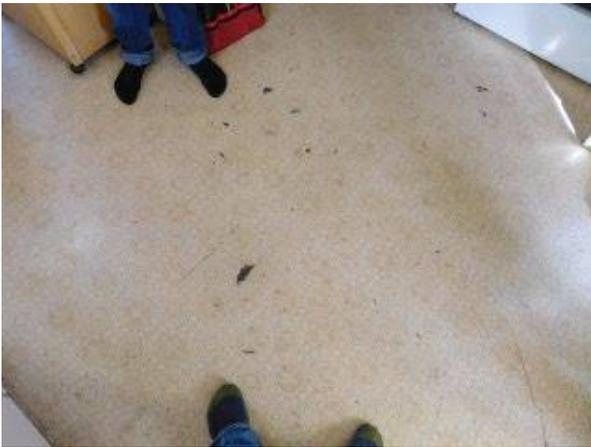
Photo 65-1

Vinyl, linoleum flooring in the kitchen was damaged and deteriorated. In a wet area, water can seep below the finish and damage the sub-floor creating a conducive condition for wood destroying organisms as a result. Recommend that a qualified contractor replace or repair flooring as necessary.
