AP Inspections, LLC

Property address: **1234 Pleasant Pl.**

Inspection date: **Thursday, March 02, 2017**

Property Inspection Report

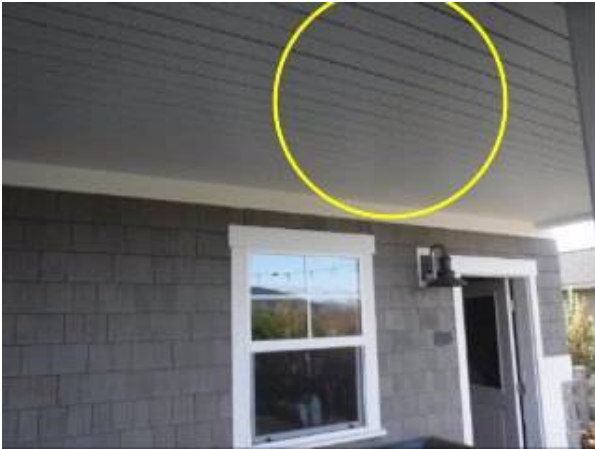
Photo 3-1

Some patio covers were obscured by wood trim finish work that covered the supporting members at basement and first floor levels and couldn't be fully evaluated.

Trim at basement level covering supporting members of the deck.

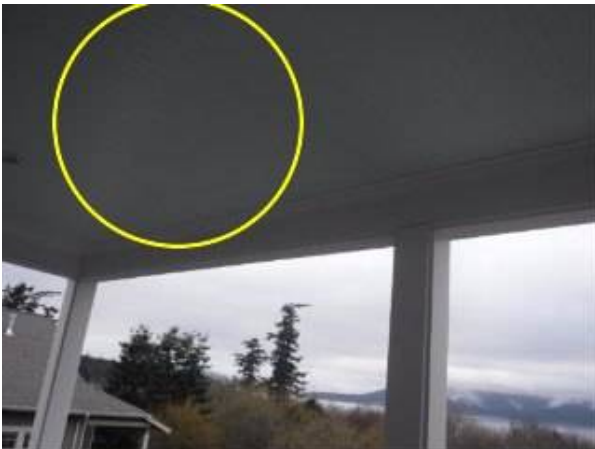
Photo 4-1

Most areas of the deck substructure were inaccessible due to wood finish material that covers the substructure.. These areas couldn't be evaluated and are excluded from the inspection.

View of the trim from the first floor balcony covering the supporting members of the second floor balcony.

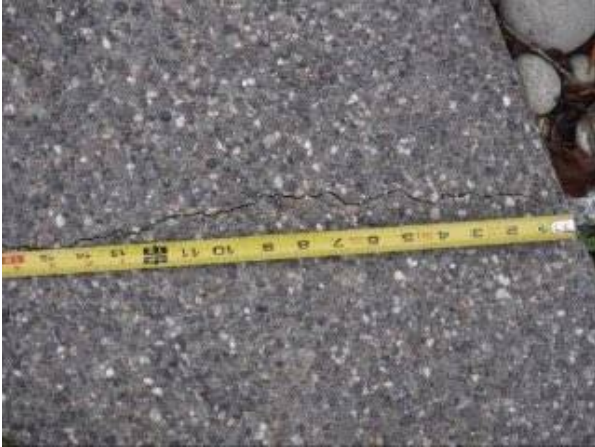
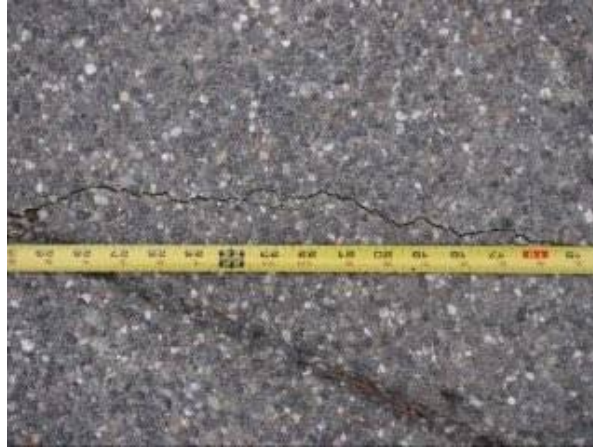
Condition of driveway: Appeared serviceable, There is a stress crack at the transition of the steep section of the driveway and where it levels off. This should be monitored for additional movement and brought to the attention of the builder. See photo's below.

Minor settlement (e.g. cracks) were found in the driveway, no trip hazards were present. The client should bring to the attention of the builder and monitor for further settlement.

Stress crack on the driveway at the transition of where the steep section begins to level off to enter the garage. Right side of the driveway.

An image showing the length of the crack, approximately 30" inches long.

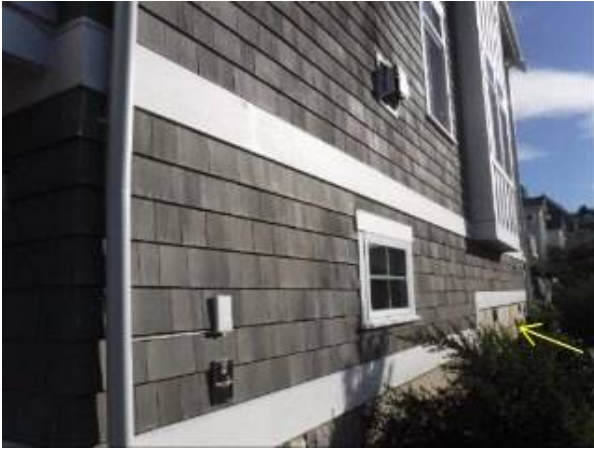
Photo 6-1

Snap ties, which are the metal ties that held the foundation forms together when the concrete was poured, have not been removed. The exposed ends of snap ties should be broken off and removed after the concrete cures. This usually causes some concrete around the ties to break loose, and the resultant void is generally filled with hydraulic cement or a non-shrinking grout. When snap ties are left in place, they rust and can allow water to seep through the foundation. Concrete exposed to rust can degrade. Recommend that a qualified person remove snap ties and patch holes with approved materials as necessary and per standard building practices.

Located along the west side of the house and inside the unfinished basement.

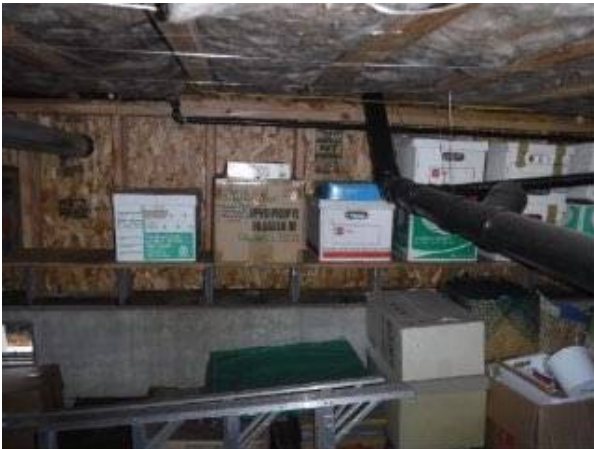
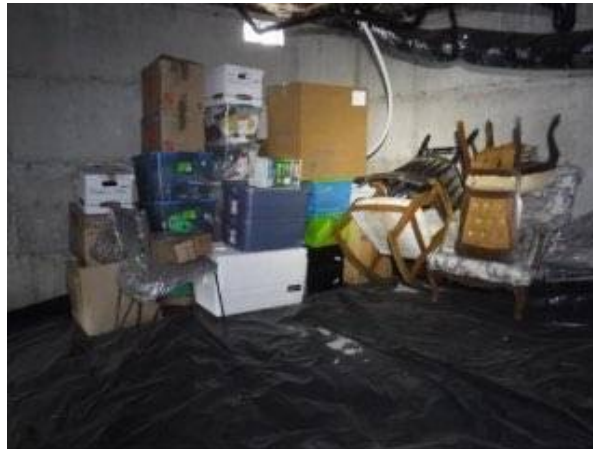
Some foundation walls below the house were obscured by stored items in the basement and crawlspace. The inspector was unable to evaluate these areas and are therefore excluded from this inspection.

View of storage against the southwest section of the foundation wall in crawlspace.

View of storage against the east section of the foundation wall in crawlspace.

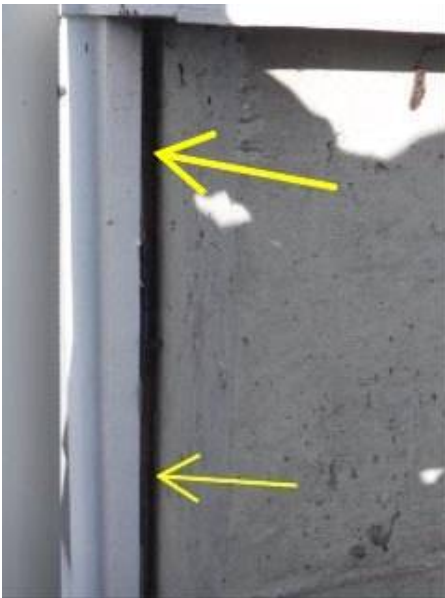
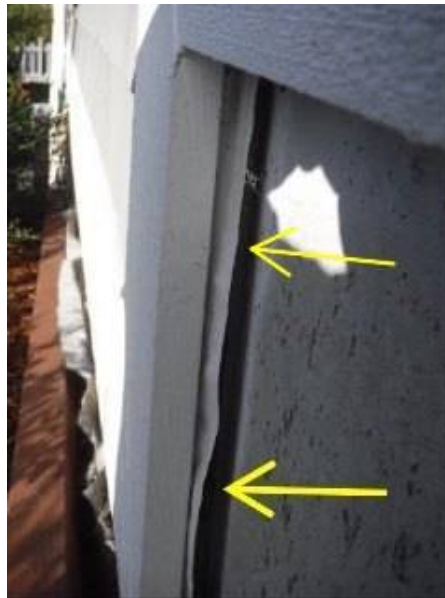
Water stains were found on wood siding visible from the crawl space at the southwest corner of the structure. There is a large gap in the siding of the house at both the southwest and northwest corners of the structure. These gaps expose the substructure to rain water and moisture which is conducive for wood destroying organisms to propagate. Recommend that a qualified person fill and seal gaps in the exterior siding located at both the southwest and northwest corners of the structure.

Photo 8-1
View of gap between siding and foundation exposing substructure at the northwest corner of the building.

Photo 8-2
View of gap between siding and foundation exposing wooden substructure at the southwest corner of the building.

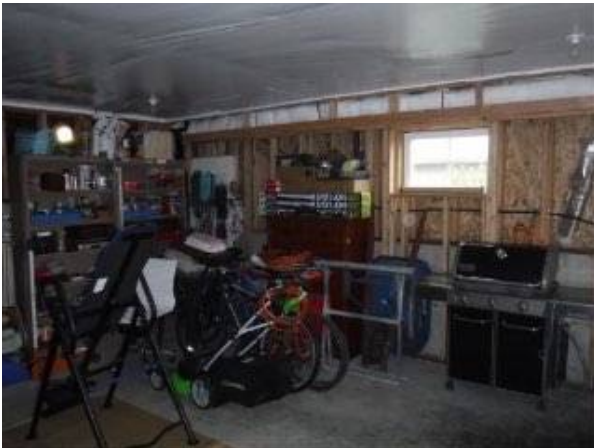
Photo 9-1

Many areas were not evaluated due to lack of access from stored items. These areas are excluded from the inspection.

Stored materials in the basement limited access to those areas of the basement and are therefore excluded from the inspection.

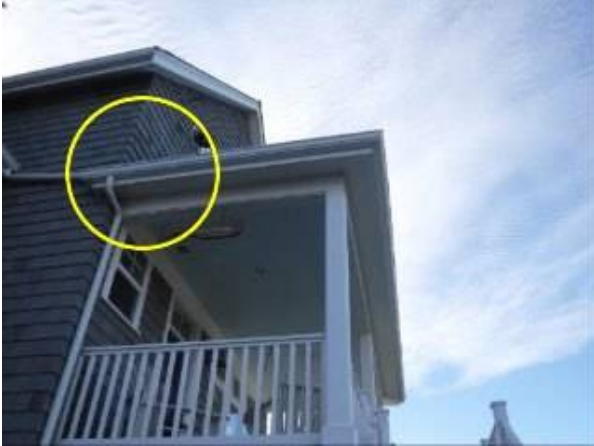
Photo 10-1

Standing water was observed in the gutter at the northeast corner downspout. Gutters can overflow and cause water to come in contact with the building exterior. This is a conducive condition for wood-destroying organisms. Recommend cleaning northeast corner downspout now and as necessary in the future.

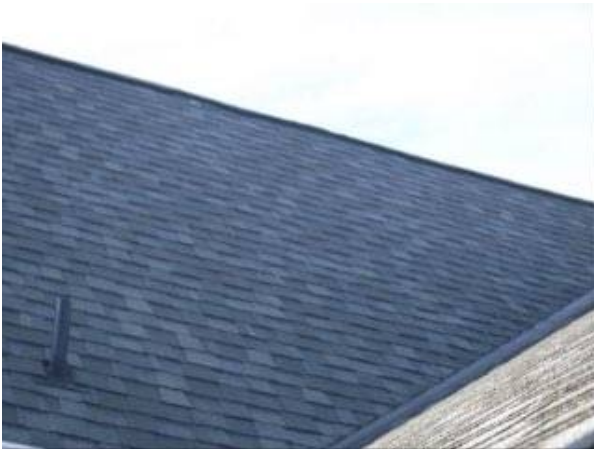
Photo 11-1

Normally the inspector attempts to traverse roof surfaces during the inspection. However, due to roof configuration (steep or very high), the inspector was unable to traverse the roof and wasn't able to fully evaluate the entire roof surface.

The 6/12 pitch of the roof made conditions too dangerous to traverse.

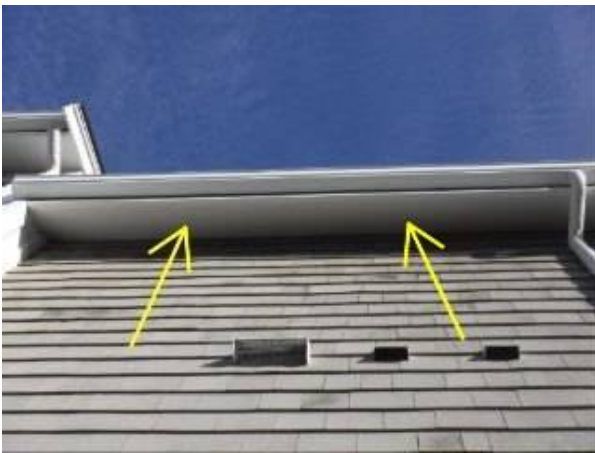
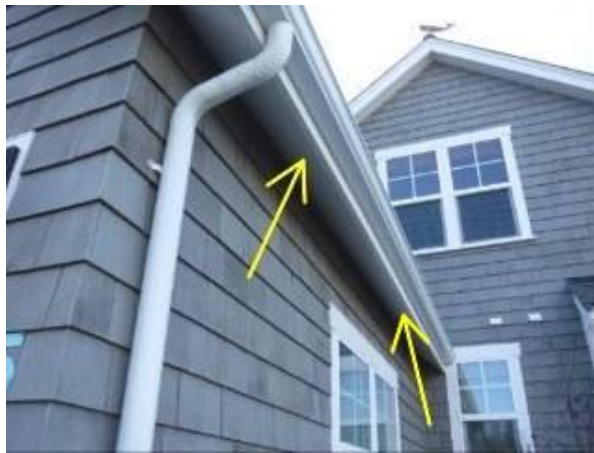
Condition of roof ventilation: Requires repair. There are no soffit vents.

Roof ventilation type: Ridge and soffit vents, however, the soffit vents have not been installed. This is a condition is conducive to wood destroying organisms due to increased levels of moisture in the attic. Ridge vents are designed to work with soffit vents in order for air to move more freely through the attic and reduce moisture.

The roof structure has inadequate venting. The soffits are not vented as per standard building practices dictate for controlling air circulation in the attic. This can result in high attic and roof surface temperatures, reduce the life of the roof covering materials, and/or increase cooling costs. High levels of moisture are also likely to accumulate in the roof structure or attic, and can be a conducive condition for wood-destroying organisms. Standard building practices require one free square foot of ventilation for every 150 square feet of attic space, and that vents be evenly distributed between the lowest points of the roof structure and the highest points to promote air circulation. Often this means that both soffit vents and ridge or gable end vents are installed. Recommend that a qualified contractor evaluate and install vents per standard building practices.

Photo 12-1
A view of one portion of the structure representative of the entire structure. No soffit vents installed.

Photo 12-2
Another view of a soffit showing no vents.

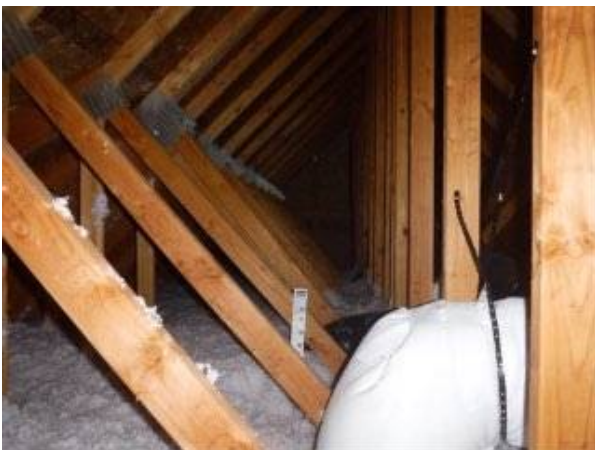
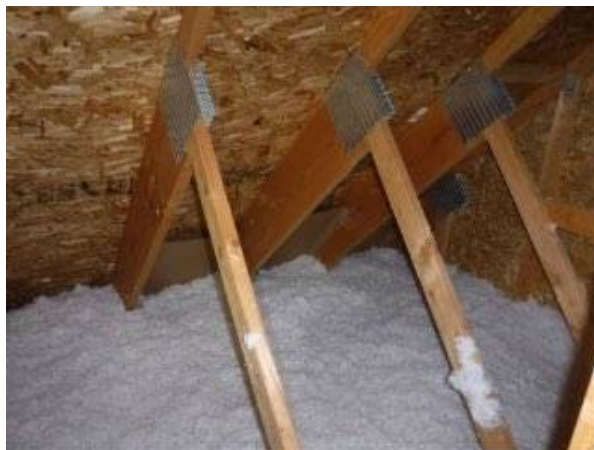
All attic areas and roof structures more than 6 feet from attic access point were inaccessible due to lack of permanent walkways and/or limited height. These areas were not evaluated and are excluded from the inspection.

Photo 13-1
Inaccessible areas of the attic due to lack of safe footing.

Photo 13-2
Lack of secure footing in the attic limited the inspection to viewing from the access space.

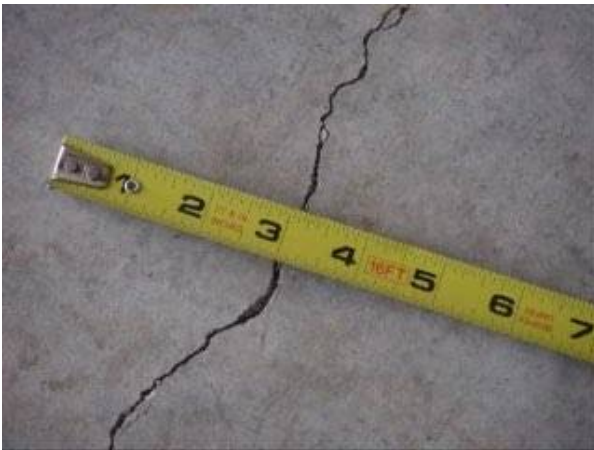
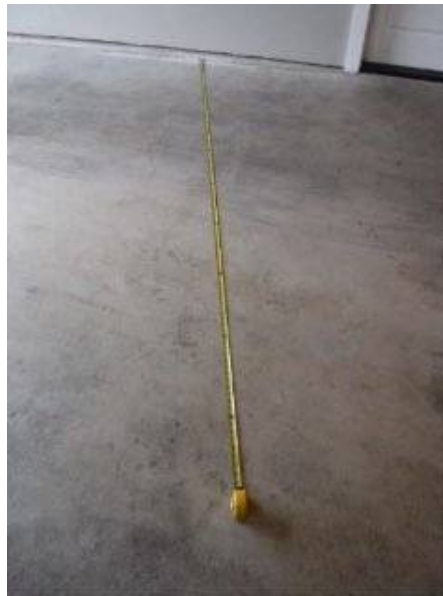
Minor cracks were found in the concrete slab floor. These are common and appeared to be only a cosmetic issue. They should be monitored for widening and lengthening.

Close-up view of crack in garage floor. To be used to monitor the crack for enlarging.

Documenting the existing length of the crack in the garage floor. Monitor cracks in the garage floor for widening and lengthening.

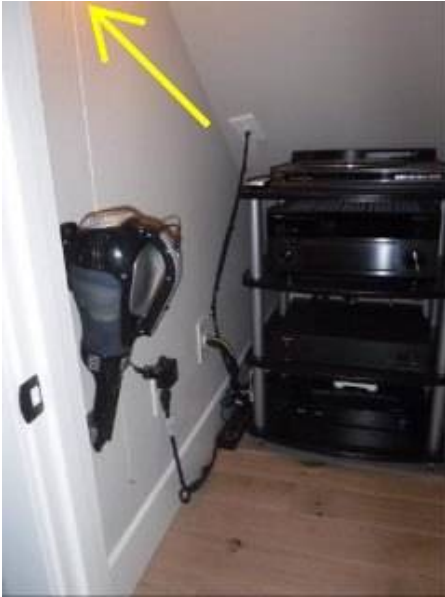
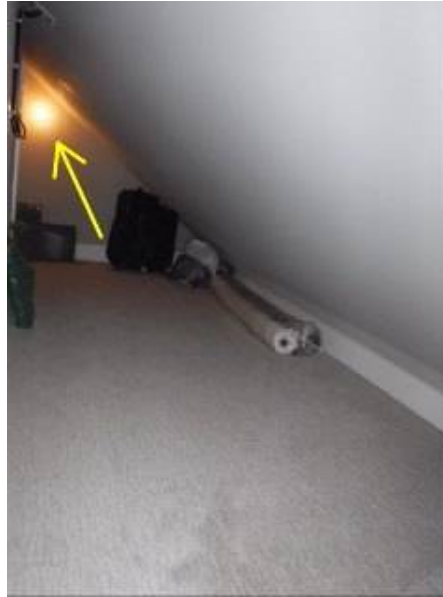
Light fixtures with fully or partially exposed incandescent bulbs were installed in two storage closets located in the second floor bonus room. There are two such lights in one closet and one in the audio/video storage closet. This is a fire hazard. Flammable stored items can come into contact with hot bulbs, or hot fragments from broken bulbs can fall on combustible materials. Closet lighting should use fluorescent light fixtures or fully enclosed incandescent fixtures. Installing a compact fluorescent lamp in a lamp holder is not an acceptable practice. If globes or covers are missing, they should be replaced. Otherwise recommend that a qualified electrician replace closet lights per standard building practices.

Photo 15-1
Exposed incandescent light bulb fixture in the audio/video cabinet.

Photo 15-2
One of two exposed incandescent light fixtures in the storage closet in bonus room on second floor.

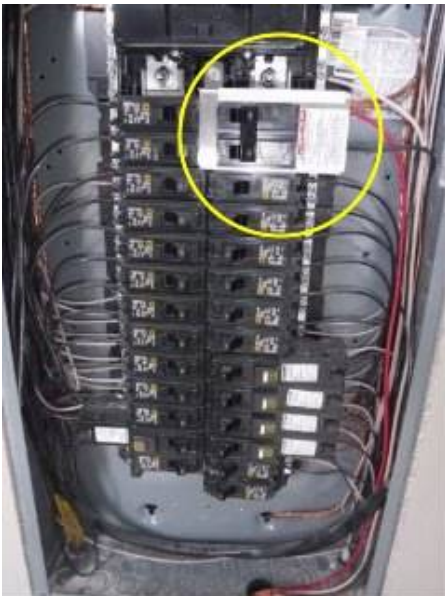
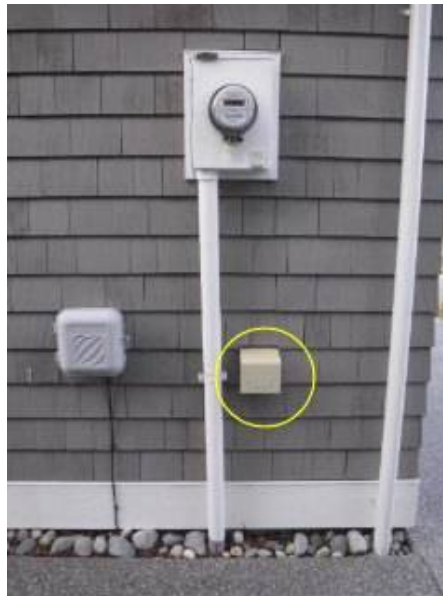
Equipment for a generator system was found. Generators, transfer switches and any associated wiring are excluded from this inspection. Recommend that the client consult with the property owner or review documentation to familiarize themselves with the operation of this system.

Photo 16-1
Transfer switch for generator connection.

Photo 16-2
Outside generator receptacle at southeast corner of garage.

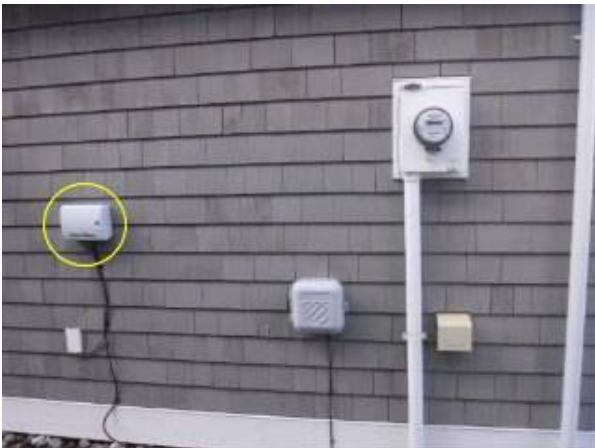
Photo 17-1

Based on visible equipment or information provided to the inspector, this property appeared to have a yard irrigation (sprinkler) system. These are specialty systems and are excluded from this inspection. Comments in this report related to this system are made as a courtesy only and are not meant to be a substitute for a full evaluation by a qualified specialist. When this system is operated, recommend verifying that water is not directed at building exteriors, or directed so water accumulates around building foundations. Sprinkler heads may need to be adjusted, replaced or disabled. Consider having a qualified plumber verify that a backflow prevention device is installed per standard building practices to prevent cross-contamination of potable water. Recommend that a qualified specialist evaluate the irrigation system for other defects (e.g. leaks, damaged or malfunctioning sprinkler heads) and repair if necessary.

Control head for the automatic sprinkler system located at the southeast corner of the garage.

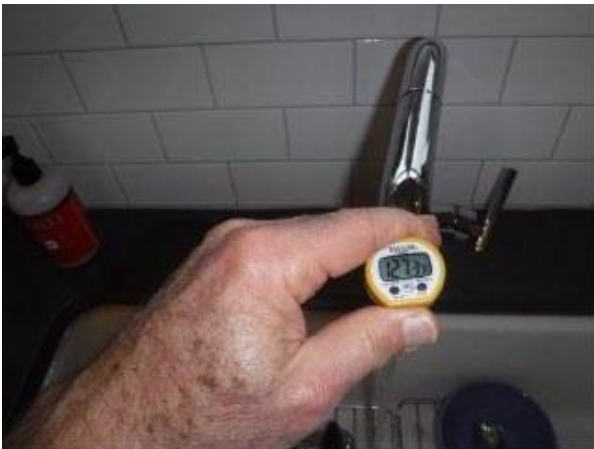
Photo 18-1

18) + The hot water temperature was greater than 120 degrees Fahrenheit. This is a safety hazard due to the risk of scalding. The thermostat should be adjusted so the water temperature doesn't exceed 120 degrees. If the water heater is powered by electricity, a qualified person should perform the adjustment, since covers that expose energized equipment normally need to be removed. For more information on scalding dangers, visit:

Thermostat reading 127 degree water temperature.

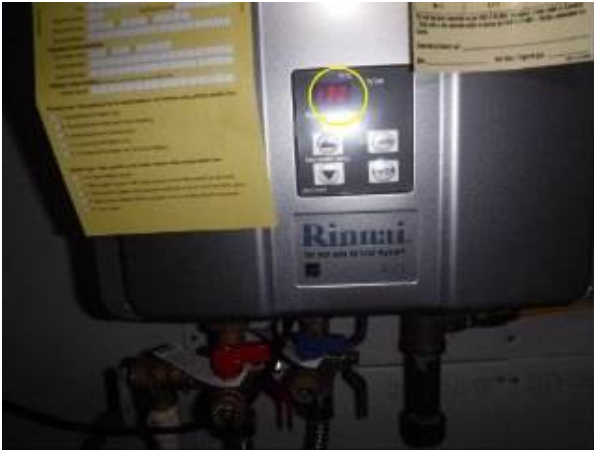
Photo 19-1

Display indicates temperature setting is at 130 degrees F. Temperature setting should be no more than 120 degrees F. to avoid scalding. This is a safety issue and should be adjusted by a qualified person knowledgeable in servicing these units.

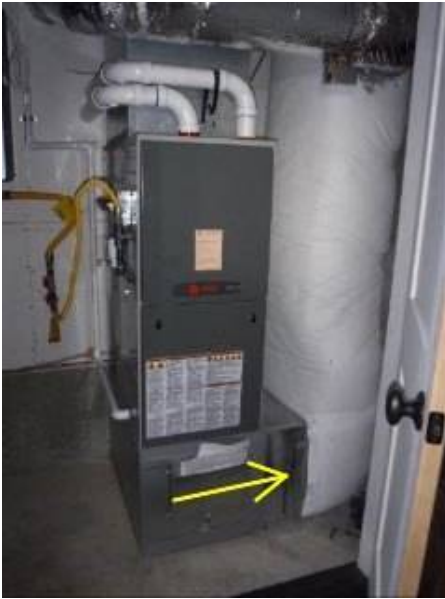
Photo 20-1

Recommend that home buyers replace or clean HVAC filters upon taking occupancy depending on the type of filters installed. Regardless of the type, recommend checking filters monthly in the future and replacing or cleaning them as necessary. How frequently they need replacing or cleaning depends on the type and quality of the filter, how the system is configured (e.g. always on vs. "Auto"), and on environmental factors (e.g. pets, smoking, frequency of house cleaning, number of occupants, the season).

Air filter housing/location.

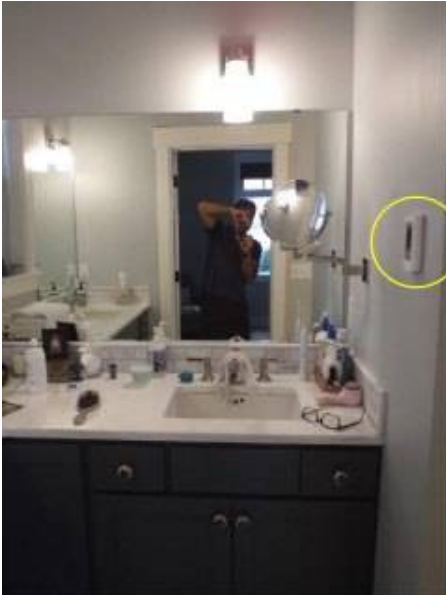
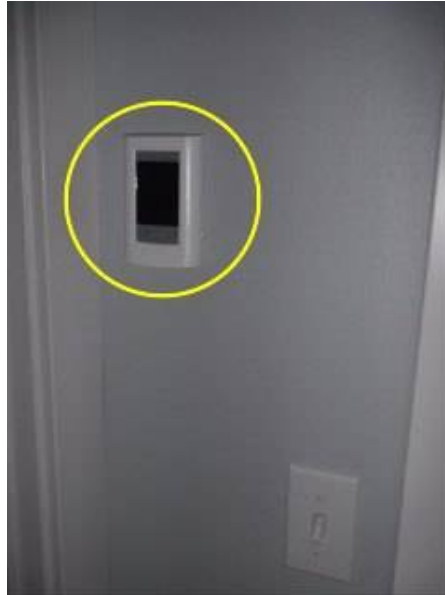
Electric in-floor radiant heating appeared to be installed in master and second level bathroom flooring. This heating appeared to be operable, but only a limited evaluation was performed because the heating elements are hidden and inaccessible. It can take a long time for these systems to warm up. Evaluating these systems is beyond the scope of a standard home inspection and they are excluded from this inspection. If concerned, consult with the property owner about their operation, review documentation, and have repairs made if necessary.

Photo 21-1
Floor heater control head in master bath.

Photo 21-2
Floor heater control head in second floor bath.

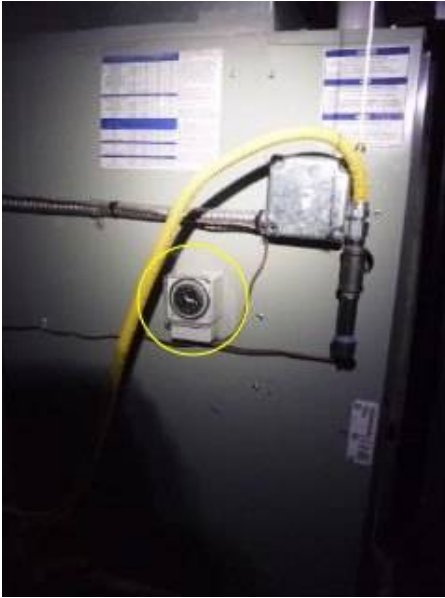
Photo 22-1

An exhaust fan with a 24 or 12 hour timer was installed and served as a simple ventilation system. The timer can be configured to operate the fan automatically one or more times per day for a set length of time. These fans help reduce moisture and stale air inside the house. Guidelines vary for when and how long such fans should be configured to operate depending on the size of the house, number of occupants and rating of the fan. Recommend reviewing instructions or documentation for the timer and configuring the fan as necessary. The inspector notes these systems when present, but does not determine their adequacy, or if the timer is operable. For more information, visit:

The timer control for the whole house fan located on the furnace housing in utility closet in basement.

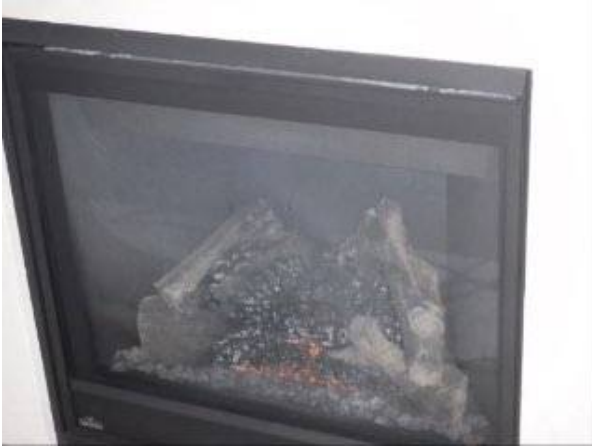
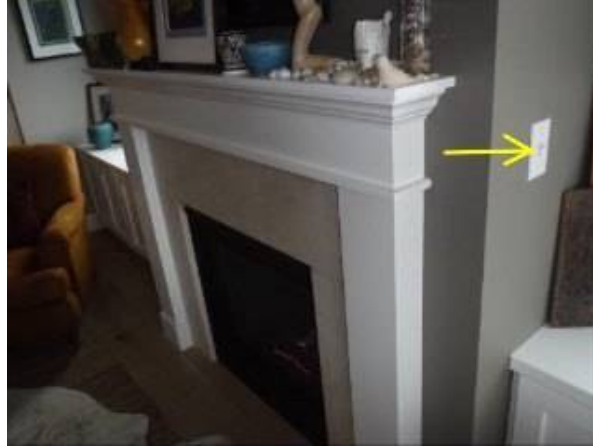
Recommend that the client review all available documentation for gas-fired fireplaces and stoves. Depending on how they are operated (for routine heating versus ambiance), such appliances may need servicing annually or every few years. Consult with the property owner and/or a qualified specialist to determine if service is needed now. Any needed repairs noted in this report should be brought to the attention of the specialist when it's serviced. For more information visit:

Direct vent gas fireplace located in living room.

Control switch for fireplace.

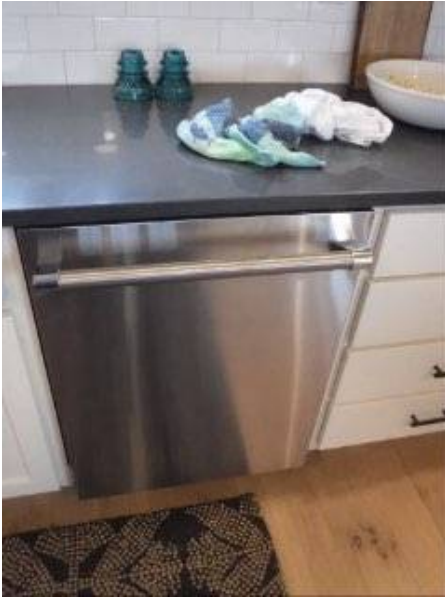
Photo 24-1

The inspector was unable to determine if the dishwasher's drain line had a high loop or air gap (e.g. drain line not visible). A high loop is created by routing the drain line up to the bottom surface of the counter top above and securely fastening it to that surface. An air gap is a device that makes the drain line non-continuous. Both of these prevent waste-water backflow from entering the dishwasher, and possibly flooding out of the dishwasher if/when a siphon occurs. Some newer dishwashers have these devices built in. Recommend reviewing the dishwasher's installation instructions, consulting with the property owner and/or having a qualified contractor evaluate further to determine if a high loop and air gap are installed or needed. If not installed, and none is built into the dishwasher, then recommend that a qualified contractor install a high loop and air gap per standard building practices.

High loop/air gap drain line not visible.

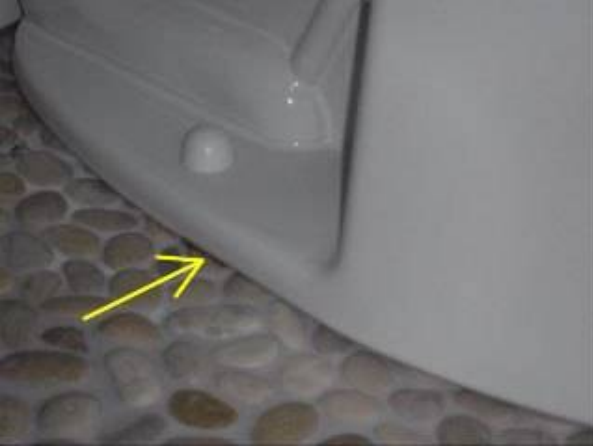
Photo 27-1

Caulk around the base of toilets located in the Master, first floor half bath and second floor bath was missing. Modern standards require caulk to be installed around the entire toilet base where it meets the floor for sanitary reasons. Without it, soiled water can soak into flooring and sub-floor materials if the toilet overflows. Condensation from the toilet can also soak into the flooring. Recommend that a qualified person caulk around toilet bases per standard building practices.

Toilet in second floor bath missing chalking at base of toilet and representative of conditions present at toilets in master and half bath rooms.

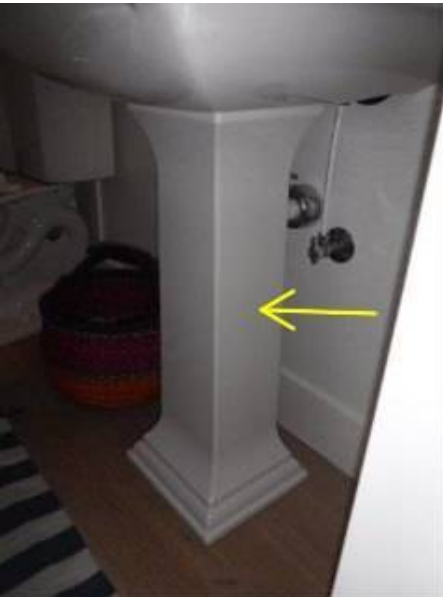
Photo 28-1

Condition of sinks and related plumbing: The base of the pedestal sink in the first floor half bathroom unsecured. Recommend that a person knowledgeable in securing the fixture repair.

Pedestal base in the first floor half bath is unsecured. To avoid possible damage of fixture, secure the pedestal fixture as recommended by the manufacturer (Kohler) of the appliance.

Unsecured pedestal base.

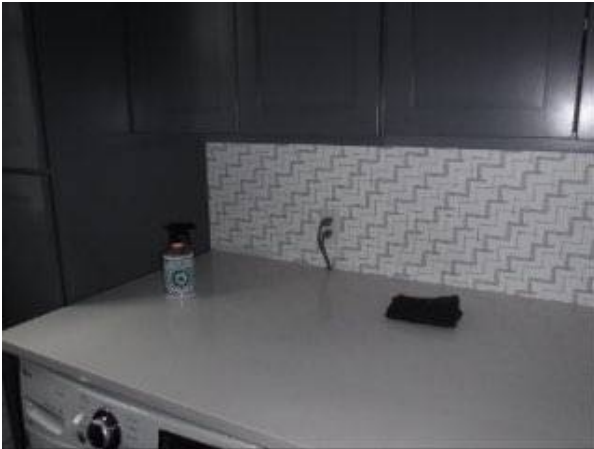
Photo 29-1

No access or only limited access was available to the back of the clothes washer and dryer, and to utility hook-ups located behind the appliances, due to the counter top installed over the washer and dryer. The inspector normally attempts to determine the presence of a gas vs. electric power supply, the configuration of the stand pipe, whether the dryer exhaust duct is serviceable, etc. Because of the lack of access, the inspector was unable to fully evaluate and/or describe the hook-ups and appliances.

Counter top prohibiting inspection behind washer and dryer.

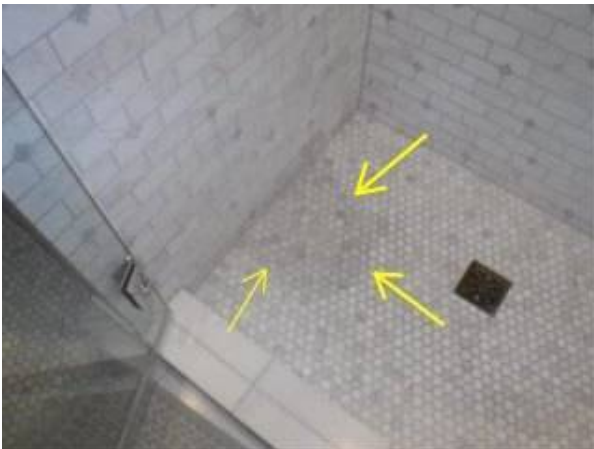
Photo 30-1

30) Master bathroom shower stall is presenting a discoloration in the pan. The inspector is unsure of the cause of this discoloration. There is no evidence of water leaks below the shower stall as noted from the crawlspace. It appears to be a cosmetic blemish but could possibly be a moisture issue from below the tile. Recommend monitoring for increased migration of the blemish to surrounding tiles on the pan. If blemish grows in size, recommend consulting with a licensed plumbing contractor.

Noted blemish in the finish of the master bath shower pan tiles.

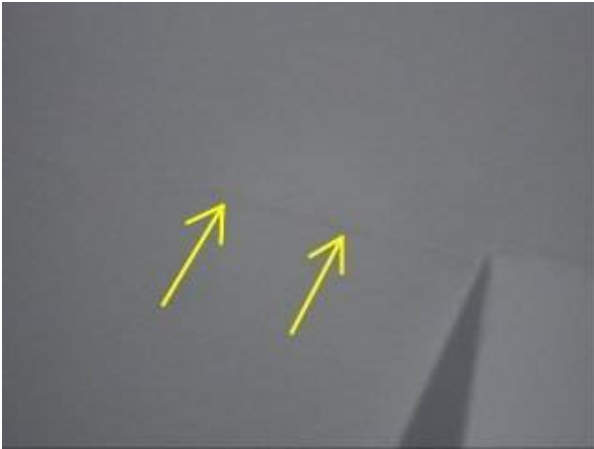
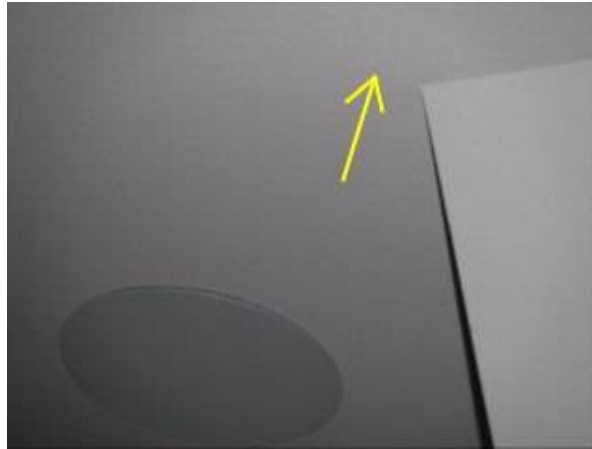
31) 🛠️ Minor cracks were found in ceilings at second floor bath and bonus room. Cracks are common and are often caused by lumber shrinkage or minor settlement, and can be more or less noticeable depending on changes in humidity. They did not appear to be a structural concern, but the client may wish to repair these for aesthetic reasons. For recurring cracks, consider using an elastic crack covering product:

Minor crack in ceiling drywall in the second floor bath room.

Minor crack in ceiling drywall located in the second floor bonus room.
