AP Inspections, LLC

Summary

Property address: **1234 Sample St.
Pleasant Pl., WA 12345**

Inspection date: **Friday, February 26, 2016**

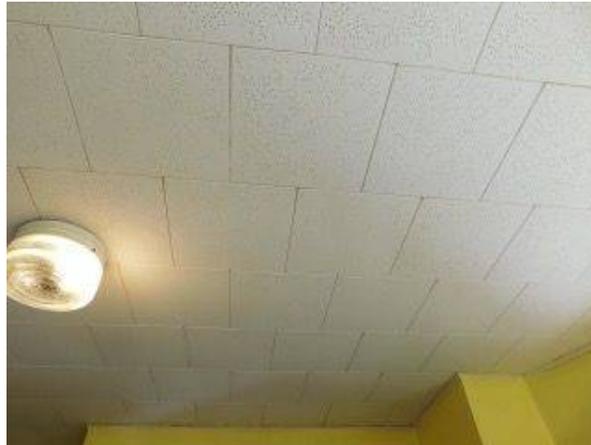
Photo 2-2

Some "cottage cheese" acoustic ceiling finishes and ceiling tiles (photo 2) are known to have asbestos contained in it. Consultation with a specialist, environmental hygienist, is recommended.

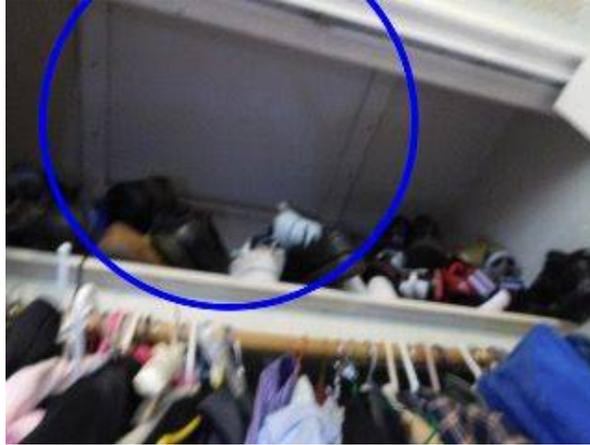
Photo 3-2

Access into the attic space inaccessible due to storage inside the closet. Unable to access the attic without damaging personal property.

Attic spaces were found but not accessed at this property. The inspector attempts to locate attic access points and evaluate attic spaces where possible. When a home is occupied, such access points may be obscured by stored items or furnishings. Home inspection standards of practice do not require inspectors to move stored items, furnishings or personal belongings. If attic access points are made accessible, a qualified person should fully evaluate those attic spaces and roof structures. Refer to image 3-2 above.

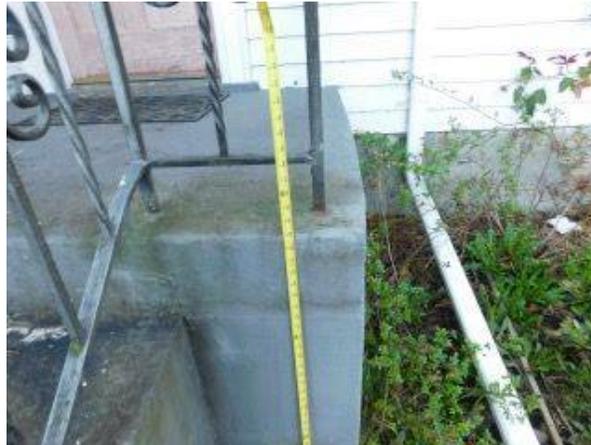
Photo 6-2

- Handrails at the front entrance flight of stairs were missing. This is a potential fall hazard. Handrails should be installed at stairs with four or more risers or where stairs are greater than 30 inches high. Recommend that a qualified contractor install handrails where missing and per standard building practices.

Image showing height of the stairway.

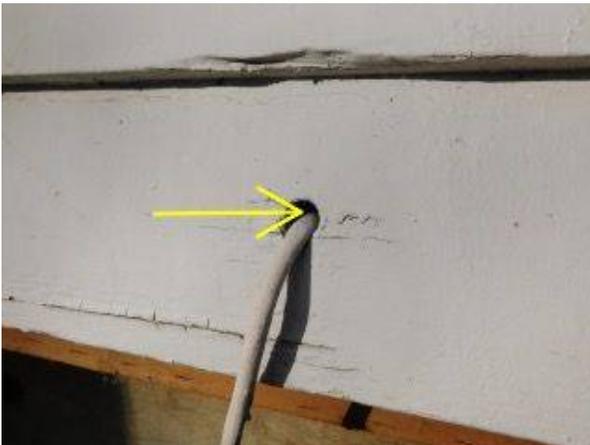
Photo 14-3

Image showing opening around cable exposing substructure to moisture. A condition conducive to wood destroying organisms.

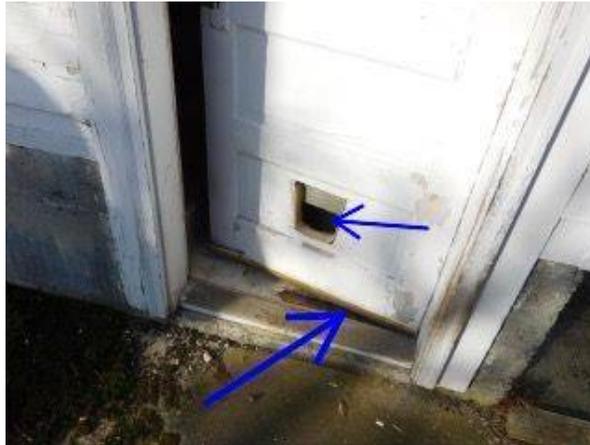
Photo 16-2

- The basement exterior entry door appears to be leaking, is damaged and deteriorated. Moisture has penetrated to the substructure of the basement stairs causing rot and presence of wood destroying organisms. Recommend contacting a qualified building contractor to repair door and stair substructure, as necessary, to prevent water from infiltrating the basement. Note that water intrusion creates a conducive condition for wood-destroying organisms.

Wood rot at the base of the exterior entry door leading to the basement. The dog door placed in the lower panel of the door exposes stairwell structure to moisture creating a conducive condition for wood destroying organisms.

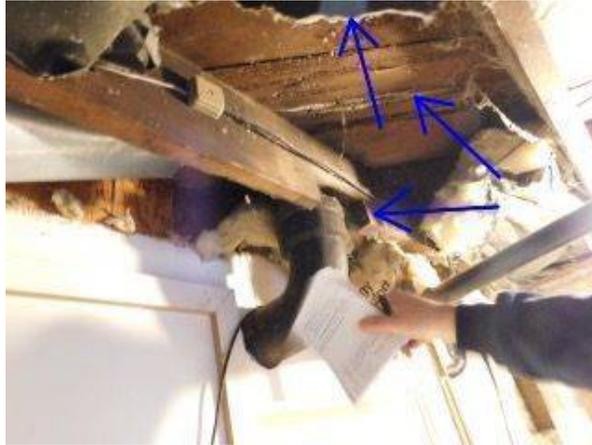
Photo 17-2

- Fungal rot was found in multiple sections of the floor sheathing. This condition presents weakening of the structural integrity of the floor causing possible collapse of the floor. Recommend consulting a qualified building contractor to evaluate and repair as necessary.

Another angle of the image showing fungal wood rot in floor sheathing and notch in floor joist.

Image showing fungal rot in the floor sheathing and improper notching of a floor joist. Recommend consulting a qualified building contractor to repair as per building standards.

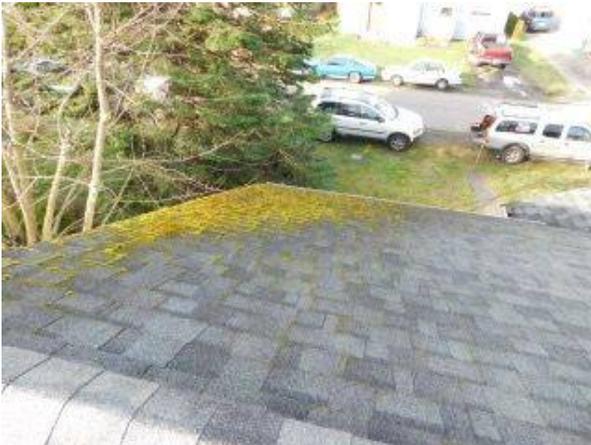
Photo 29-1

Moss was growing on the roof. As a result, shingles can lift or be damaged. Leaks can result and/or the roof surface can fail prematurely. Efforts should be made to kill the moss during its growing season (wet months). Typically, zinc or phosphate-based chemicals are used for this and must be applied periodically. For information on various moss treatment products and their pros and cons, visit:

Image showing moss growth on the roof.

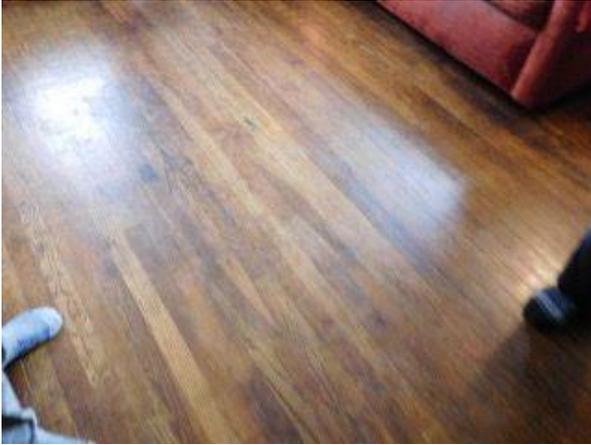
Photo 68-1

The finish of the wood flooring located in the livingroom was significantly worn and deteriorated. Recommend consulting with a qualified contractor regarding refinishing the flooring as necessary.

Image of the living room flooring.
